Observations of Pest Horse Impacts in the Australian Alps, March 2013

Graeme L. Worboys and Ian Pulsford

2013 Observations of Pest Horse Impacts in the Australian Alps

[Observations arising from an inspection of the Big Boggy River, Cascade Creek, Ingegoodbee River and Murray River headwater catchments, Kosciuszko National Park, 22 and 23 March 2013.]

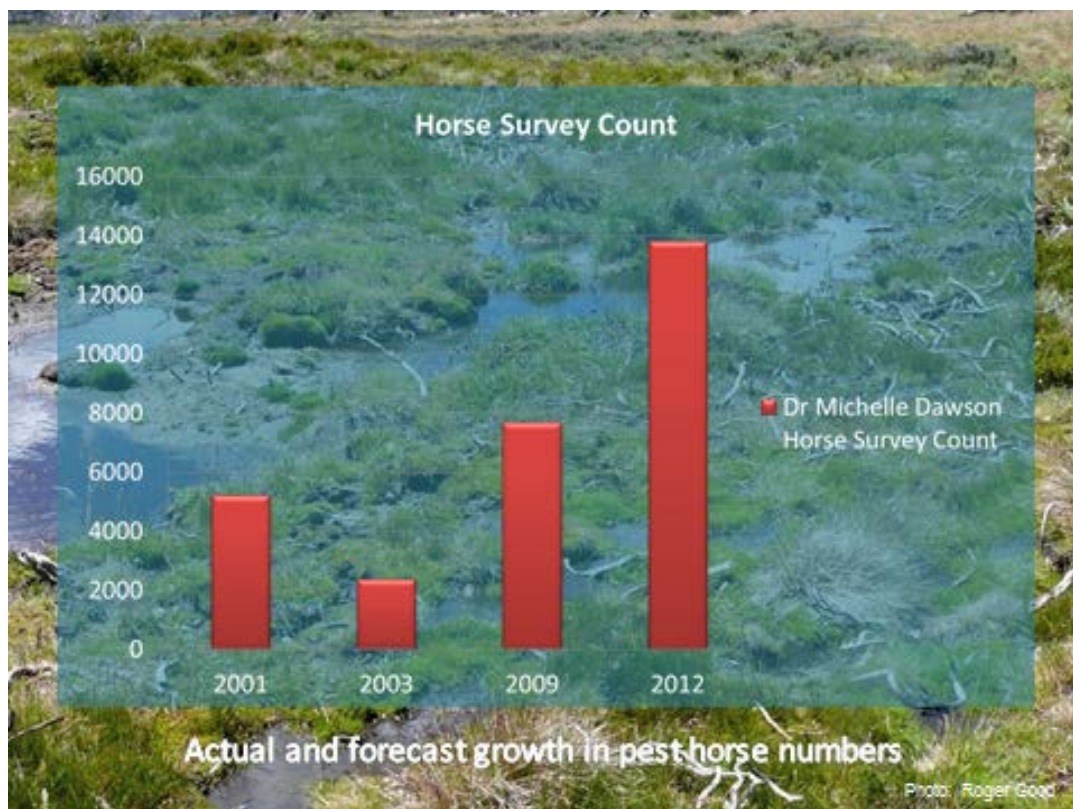
(2001) that estimated the horse population to be three times that number with densities in the Big Boggy of about 2 horses per square kilometre and Cowombat populations stable to be 6.4 per square kilometre (Dawson 2005). She also estimated horse numbers to be about 5200 horses for all aerial surveyed areas in the Australian Alps national parks. This population count was completed immediately prior to the 2003 Australian Alps fires. A post fire 2003 aerial survey found horses to be impacted by the event and the population was estimated to be about 2369. A 2009 aerial survey found the population to be about 7679 and this represented an annual increase of 21% per annum from 2003 (Dawson 2009a). This was despite live capture and removal action by park agencies. Michelle Dawson (2009) also forecast a pest horse population of 13,800 by 2012 (Figure 1).

(Figure 1) Pest horse population estimates and forecast growth (After Michelle Dawson 2009a).

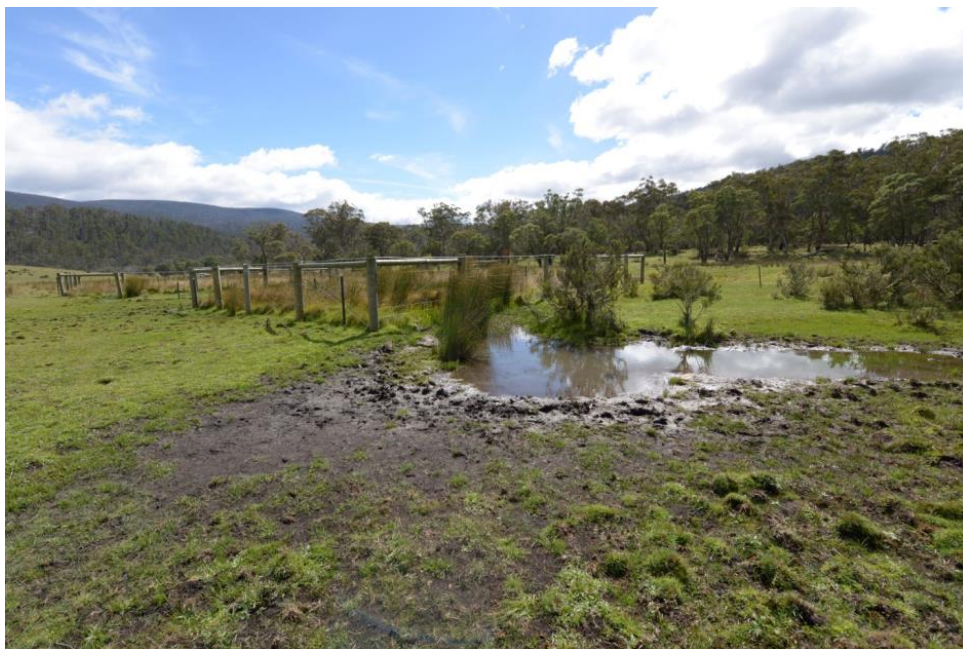
Horse impacted vegetation surrounding a 1999 enclosure plot with its protected vegetation, Cowombat Flat, Victorian Alpine National Park, near the NSW border, 23 March 2013 (Source: Graeme L. Worboys).

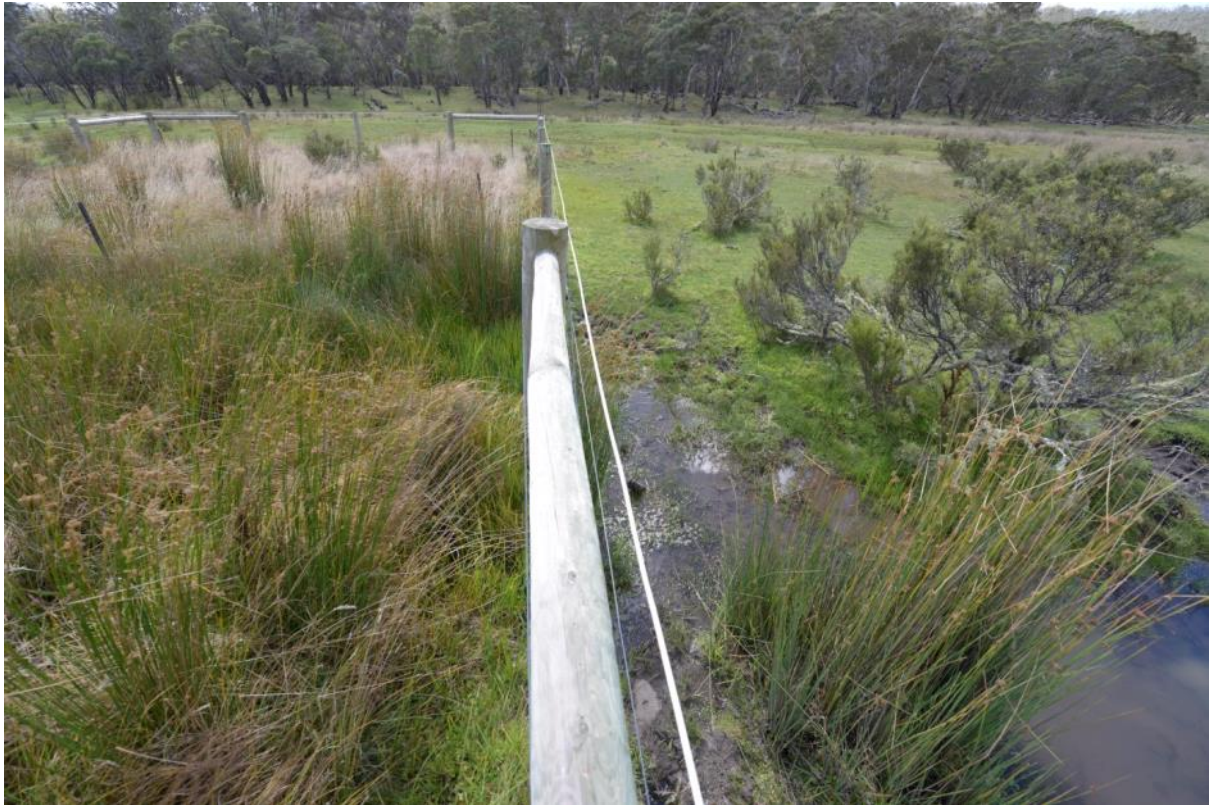
1999 exclusion plot fence with protected (left) and unprotected vegetation, Cowombat Flat, Victorian Alpine National Park, 23 March 2013 (Source: Graeme L. Worboys).

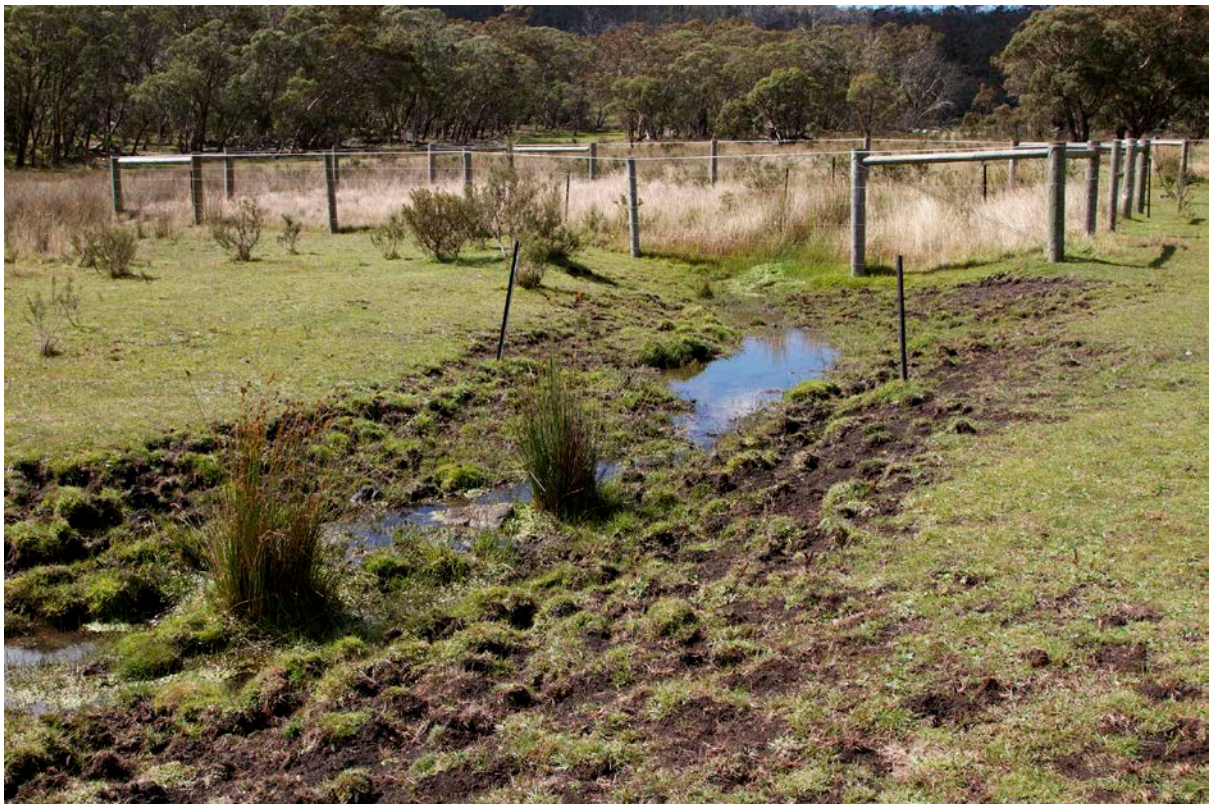
Creek (flowing from right to left) bank impacted by horses as it emerges onto Cowombat Flat from dense regenerated wetland habitat within a 1999 exclusion plot (Source: Ian Pulsford).

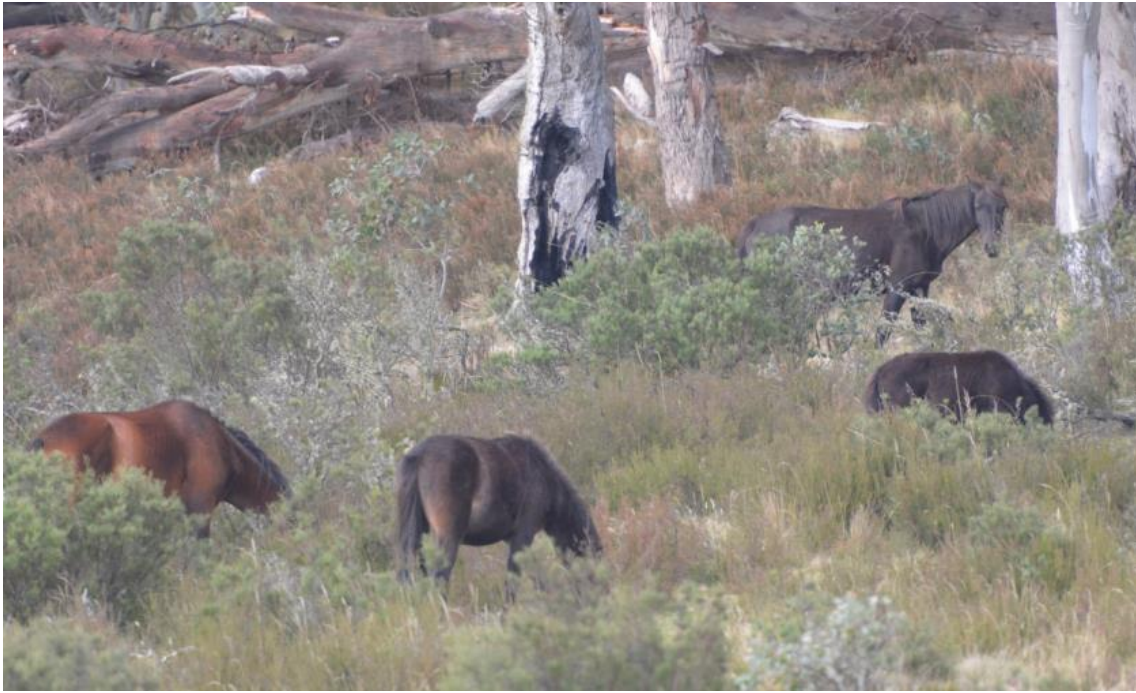
Pest horses grazing in wet heath habitats, Ingeegoodbee River near Tin Mines Hut, 23 March 2013, Kosciuszko National Park, (Source: Graeme L. Worboys).

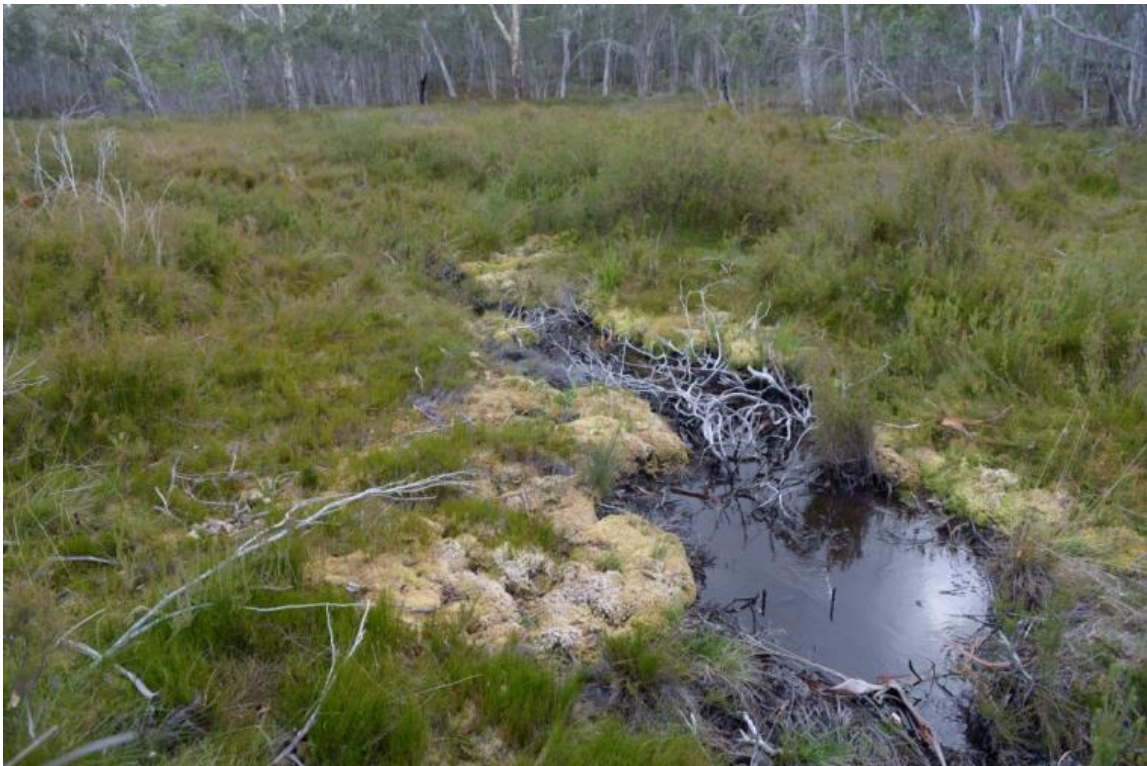
Grazing and trampling of sphagnum and wetland species (an Endangered Ecological Community), Tin Mines Track between Cascades Hut and Tin Mines Hut, Kosciuszko National Park 22 March 2013 (Source: Graeme L. Worboys).

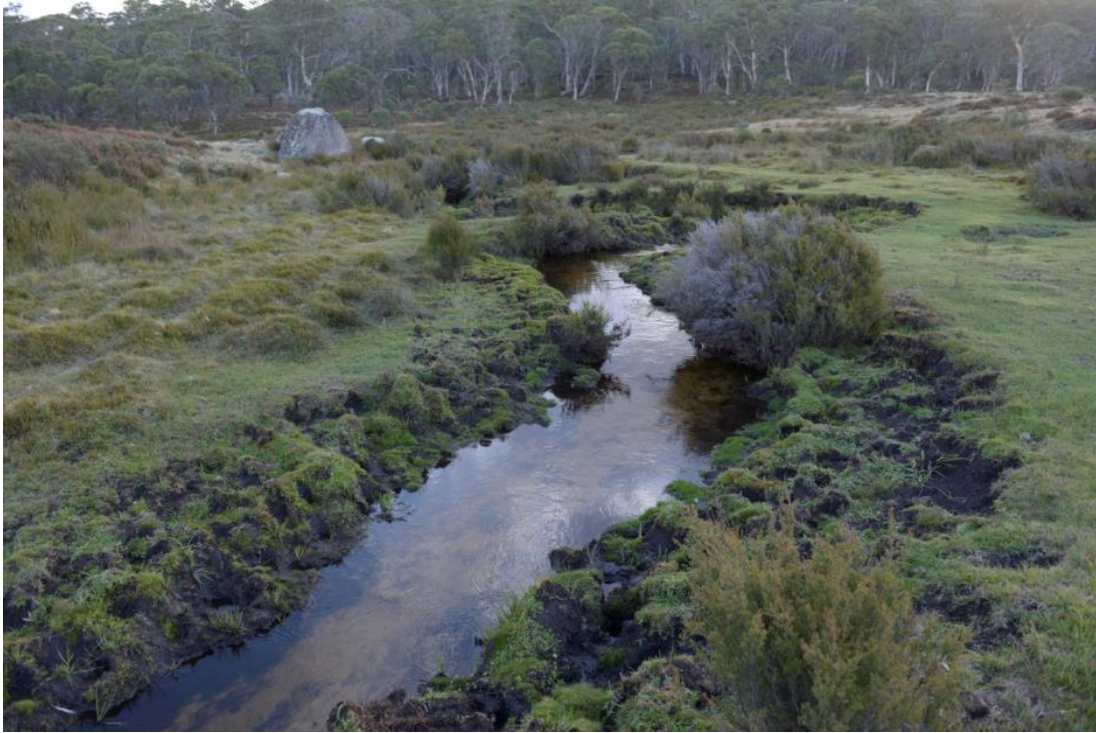
Horse trampling impacts to stream banks and stream bank collapse, headwaters of the Ingeegoodbee River near Tin Mines Hut, Kosciuszko National Park, 22 March 2013 (Source: Graeme L. Worboys).

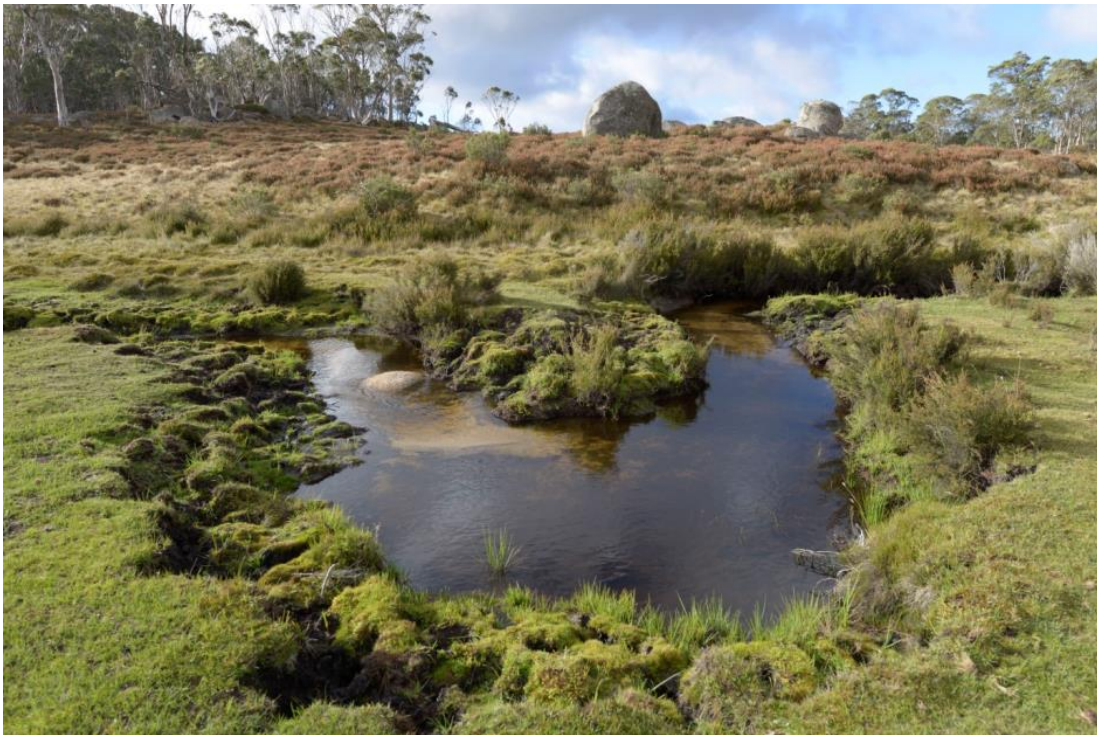
Horse trampling impacts to stream banks and stream bank collapse, headwaters of the Ingeegoodbee River near Tin Mines Hut, Kosciuszko National Park, 23 March 2013 (Source: Graeme L. Worboys).

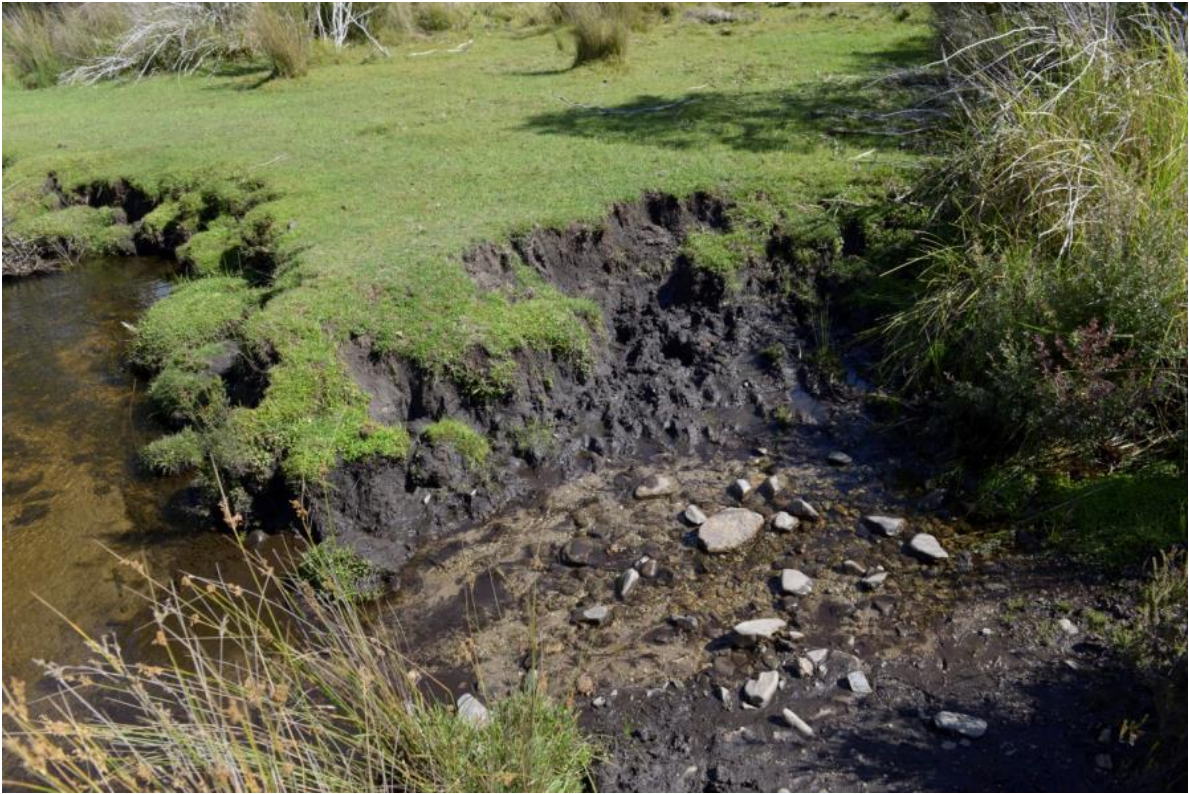
Flat compacted and altered vegetation combined with stream bank trampling and grazing impacts by horses, headwaters of the Ingeegoodbee River between Tin Mines Hut and Freebody's Hut, Kosciuszko National Park, 23 March 2013 (Source: Graeme L. Worboys).

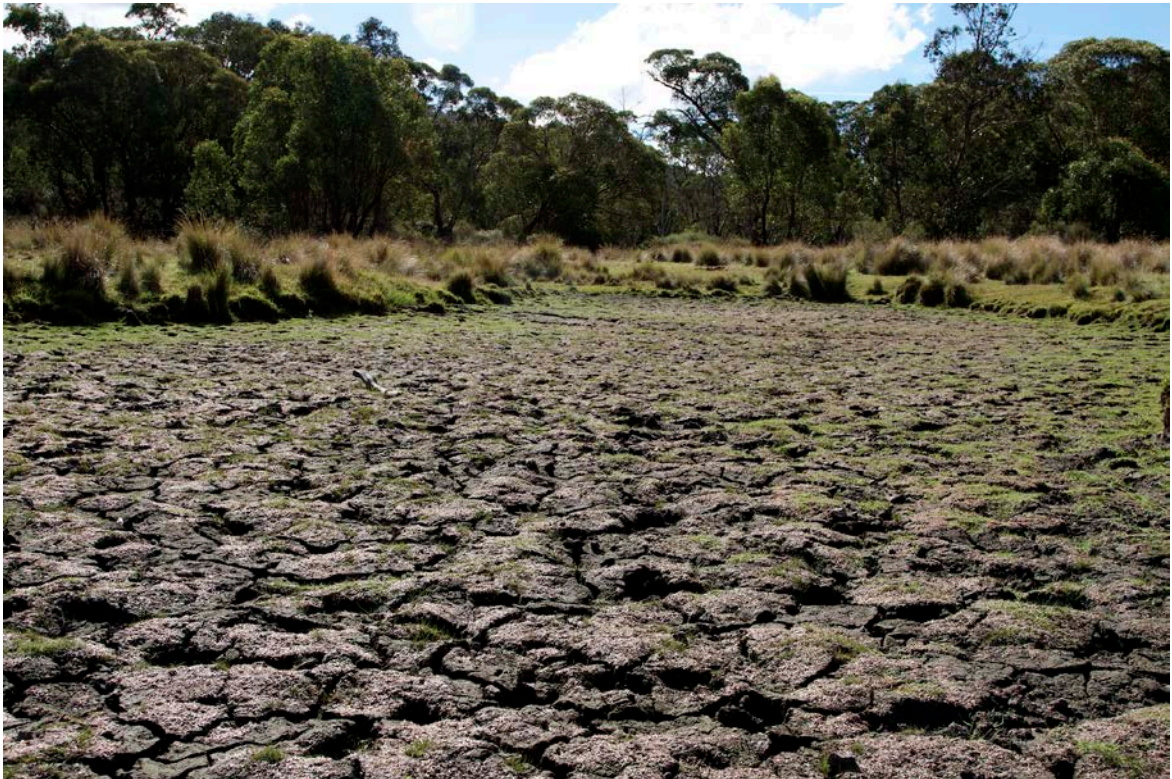
Former sub-alpine riparian bog trampled and transformed into a large mud pan by horses in the upper headwaters of the Ingeegoodbee River, 23 March 2013 (Source: Ian Pulsford).

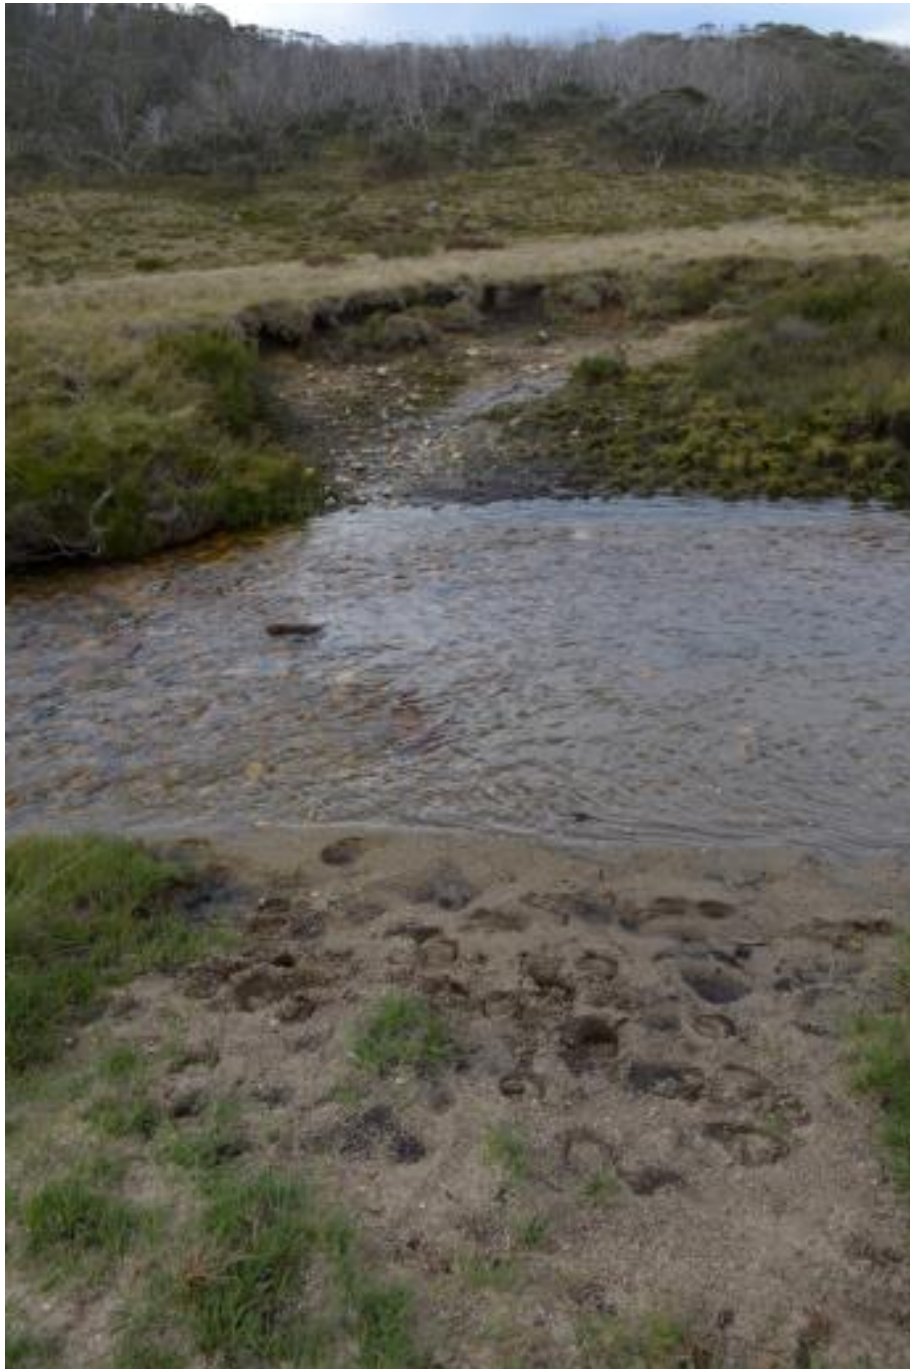
Horse use of a crossing of the Big Boggy River, headwaters of the Thredbo River and a tributary of the Snowy River, Kosciuszko National Park, 22 March, 2013 (Source: Graeme L. Worboys).

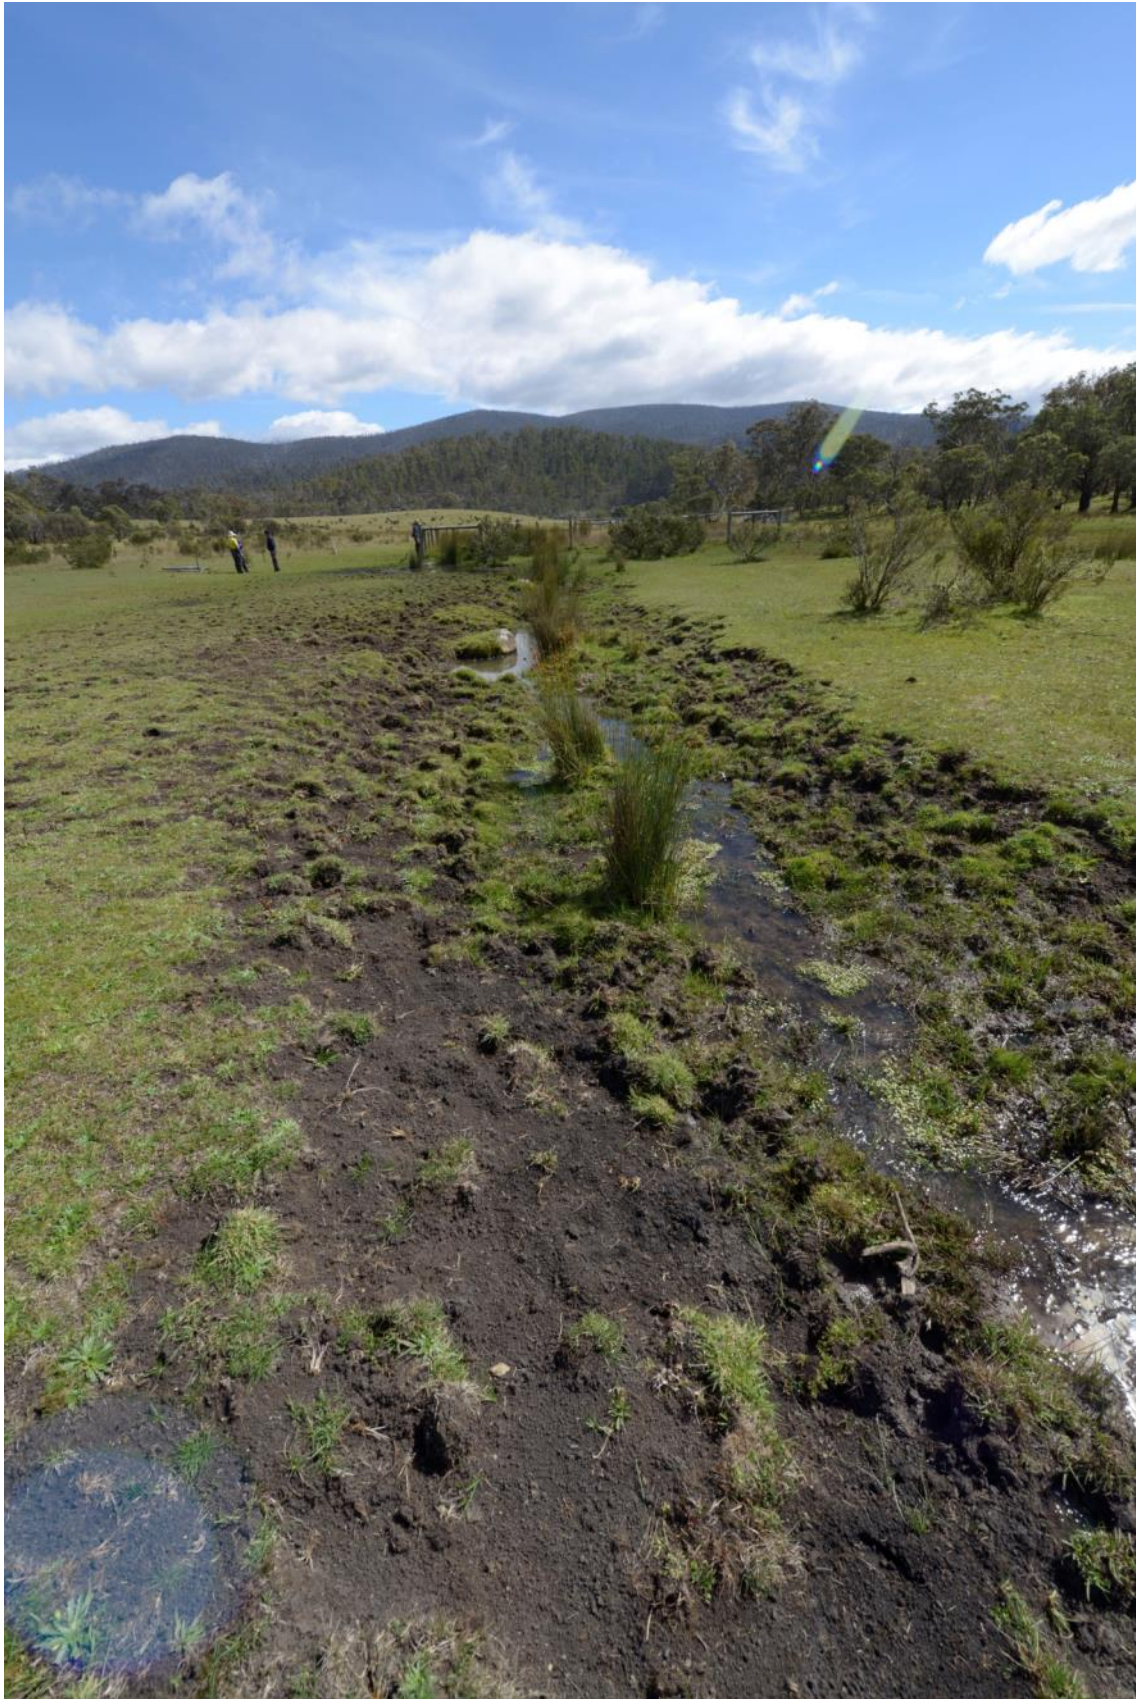
Pest horse impacts at the very headwaters of the Murray River, Cowombat Flat, Victoria, upstream of the exclusion plots, Victoria Alpine National Park, (and 100 metres from the NSW and Kosciuszko National Park border) 23 March 2013 (Source: Graeme L. Worboys).

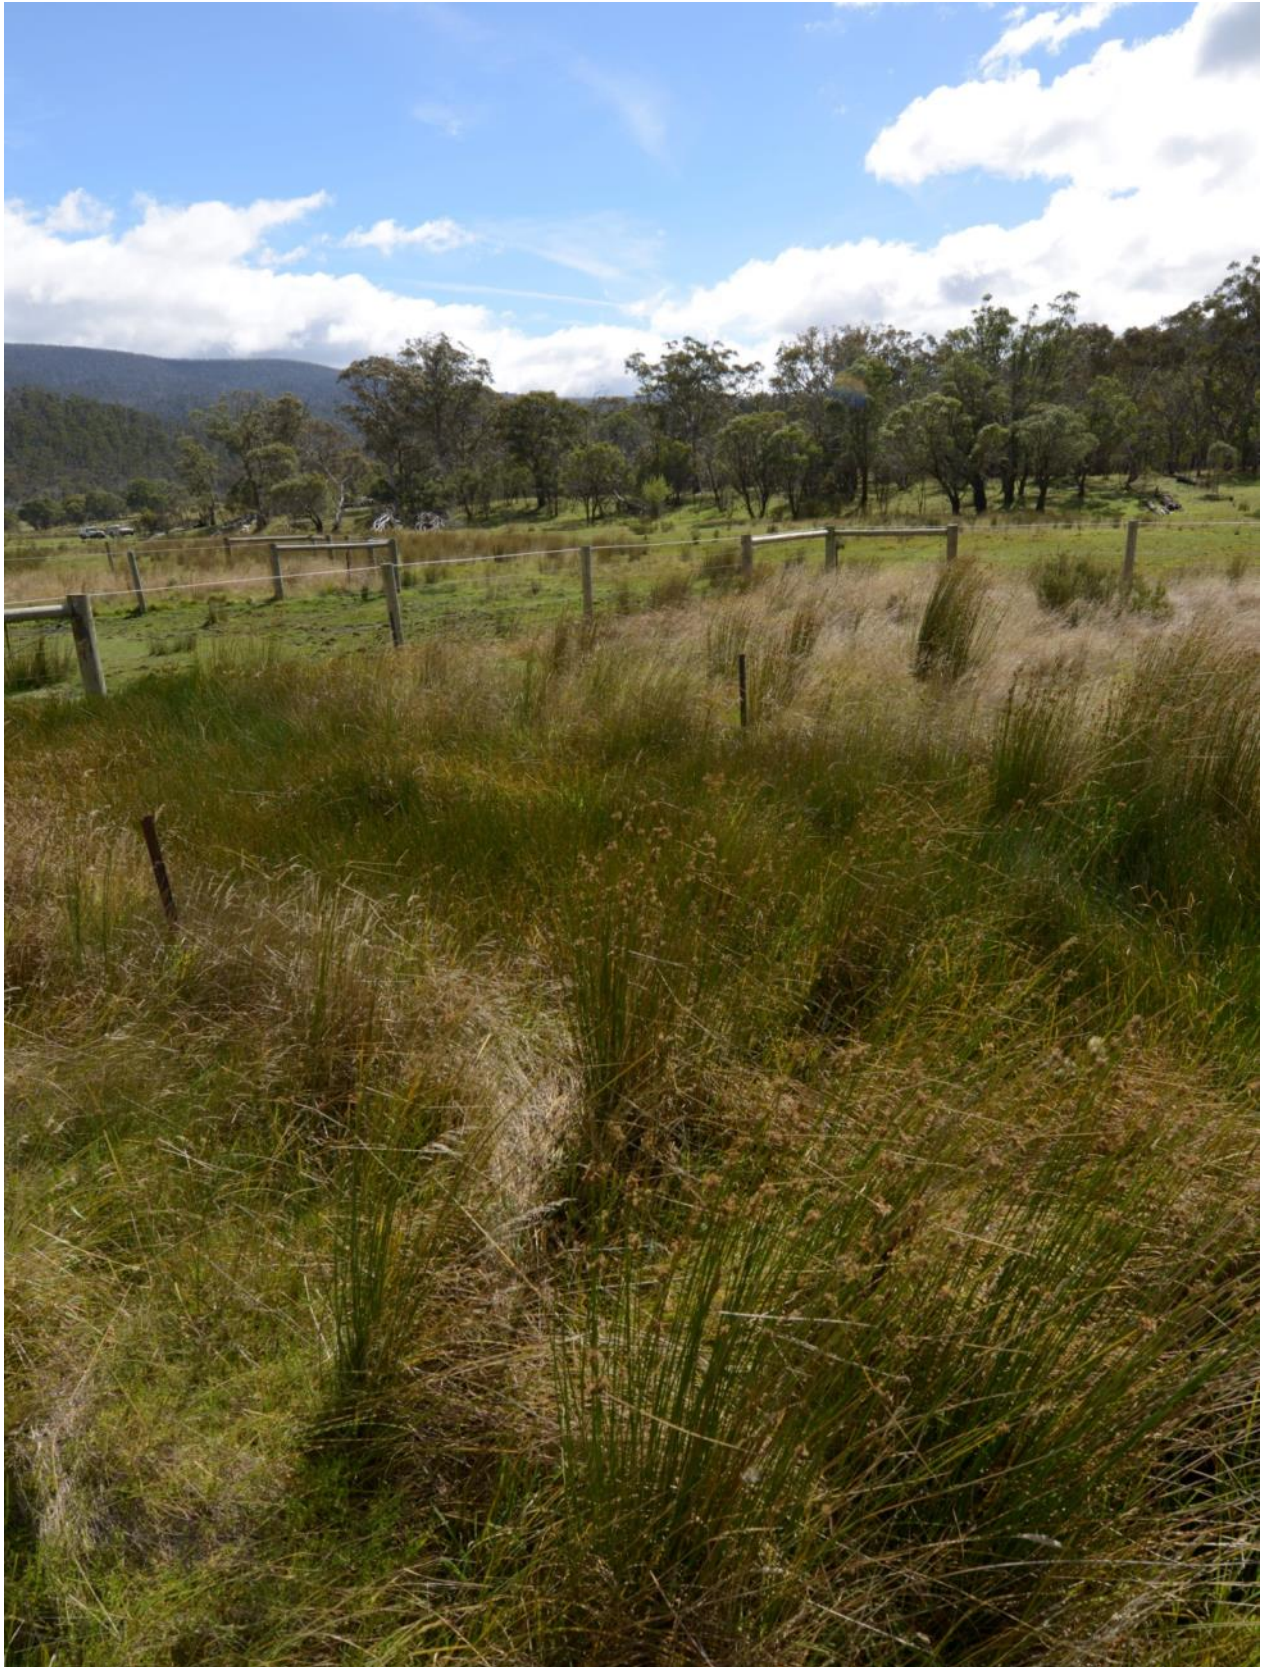
Interior of a small pest horse grazing and trampling exclusion plot that has been free of pest horse impacts for 14 years; headwaters of the Murray River, Cowombat Flat, Victoria, Victorian Alpine National Park (100 metres from the NSW and Kosciuszko National Park border) 23 March 2013 (Source: Graeme L. Worboys).

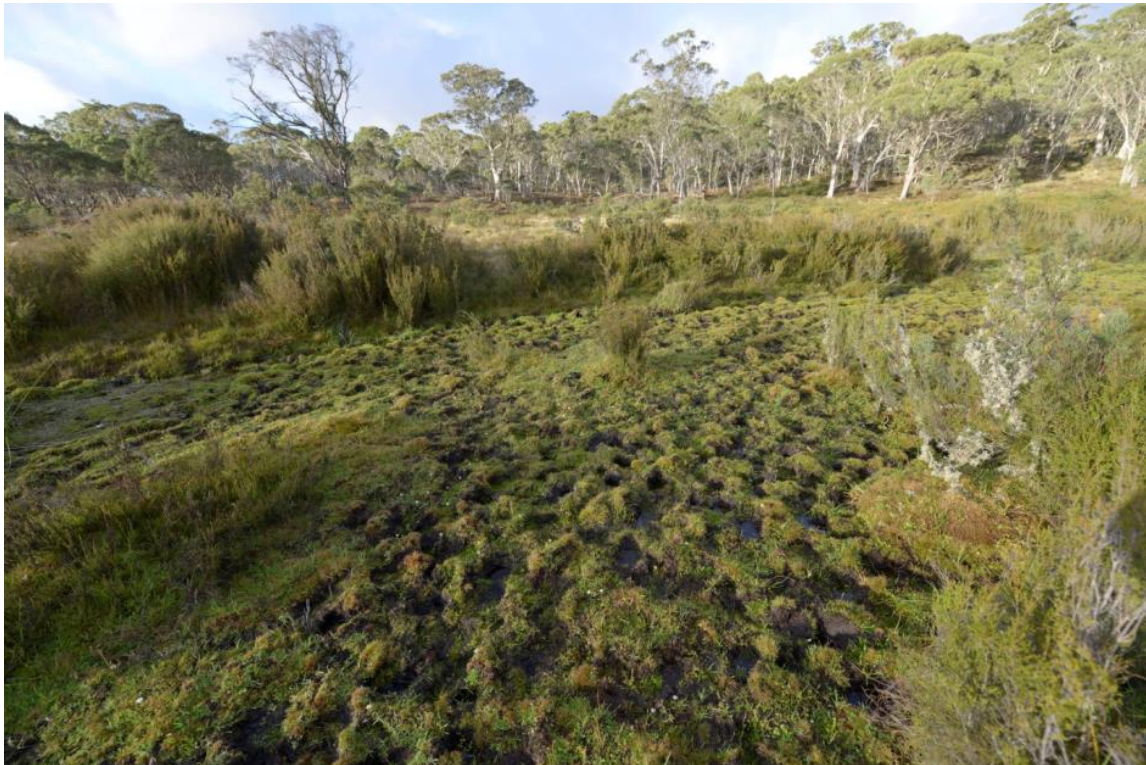
Trampling impacts to a sub-alpine bog near Tin Mines Hut, Kosciuszko National Park, 23 March 2013
(Source: Graeme L. Worboys).

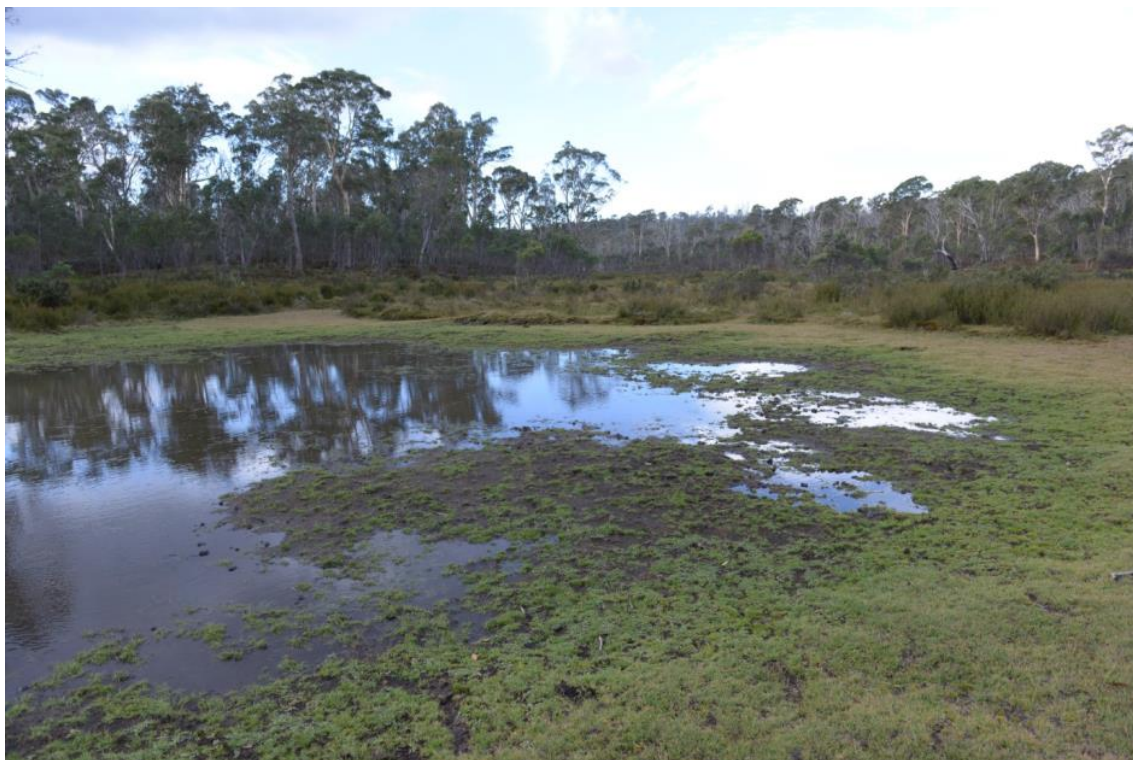
Trampling impacts to a former wet heath and sub-alpine bog between Cascades Hut and Tin Mines Hut, Kosciuszko National Park, 22 March 2013 (Source: Graeme L. Worboys).

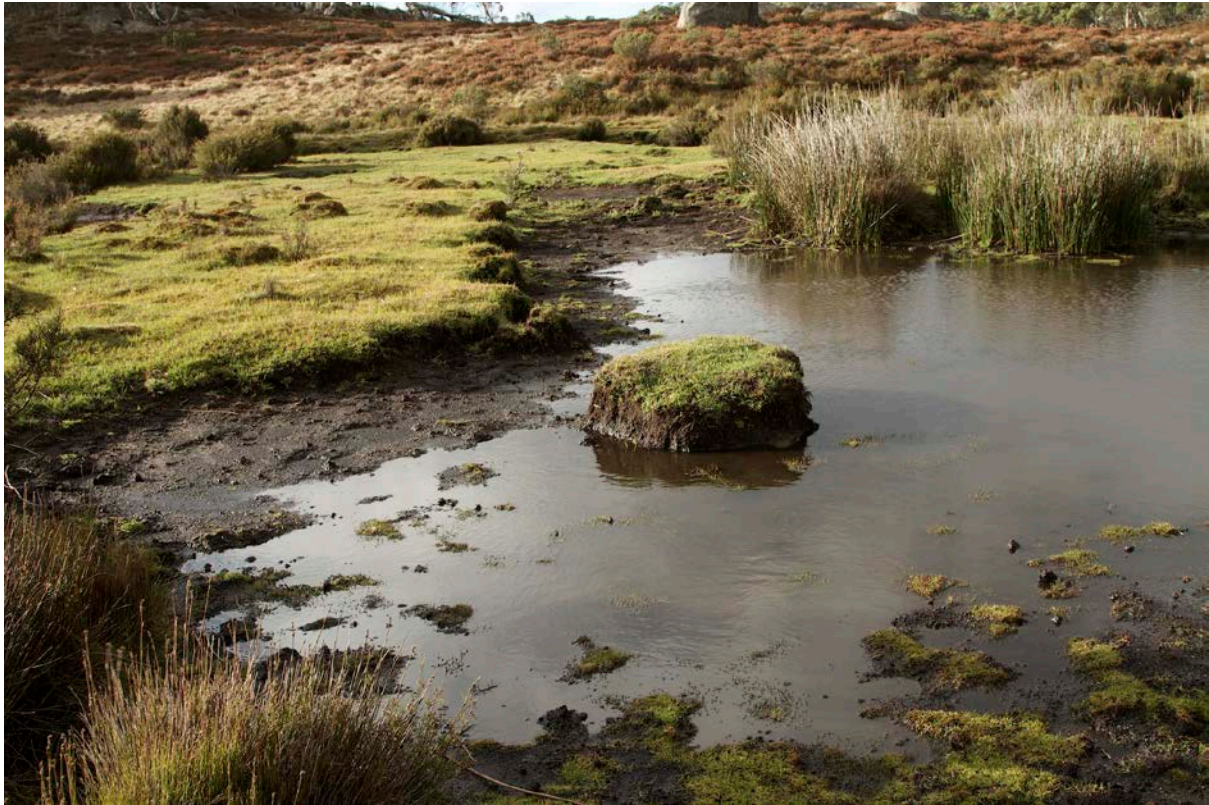
Trampling impacts to a wetland area at Tin Mines Hut, Kosciuszko National Park, 23 March 2013 with remnant soil pedestal (Source: Ian Pulsford).

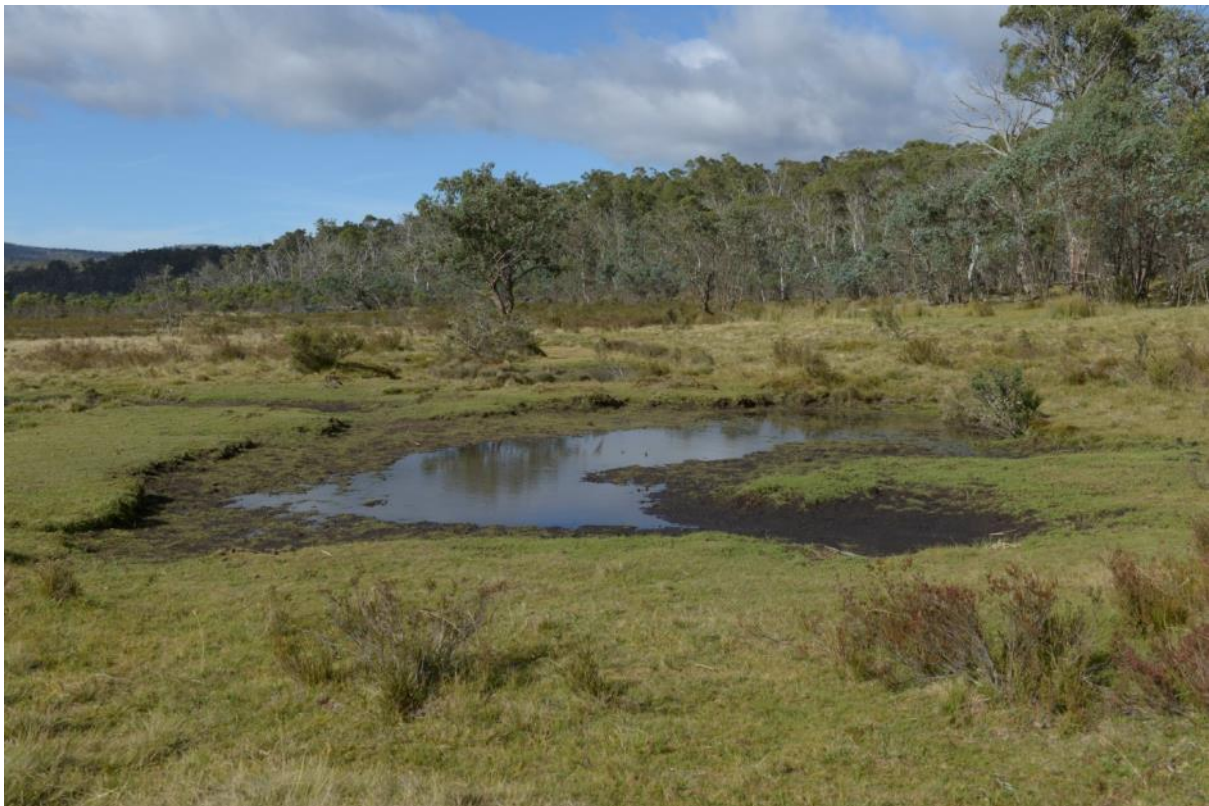
Trampling impacts to a wetland area between Tin Mines Hut and Mt Pilot, Kosciuszko National Park, 23 March 2013 (Source: Graeme L. Worboys).

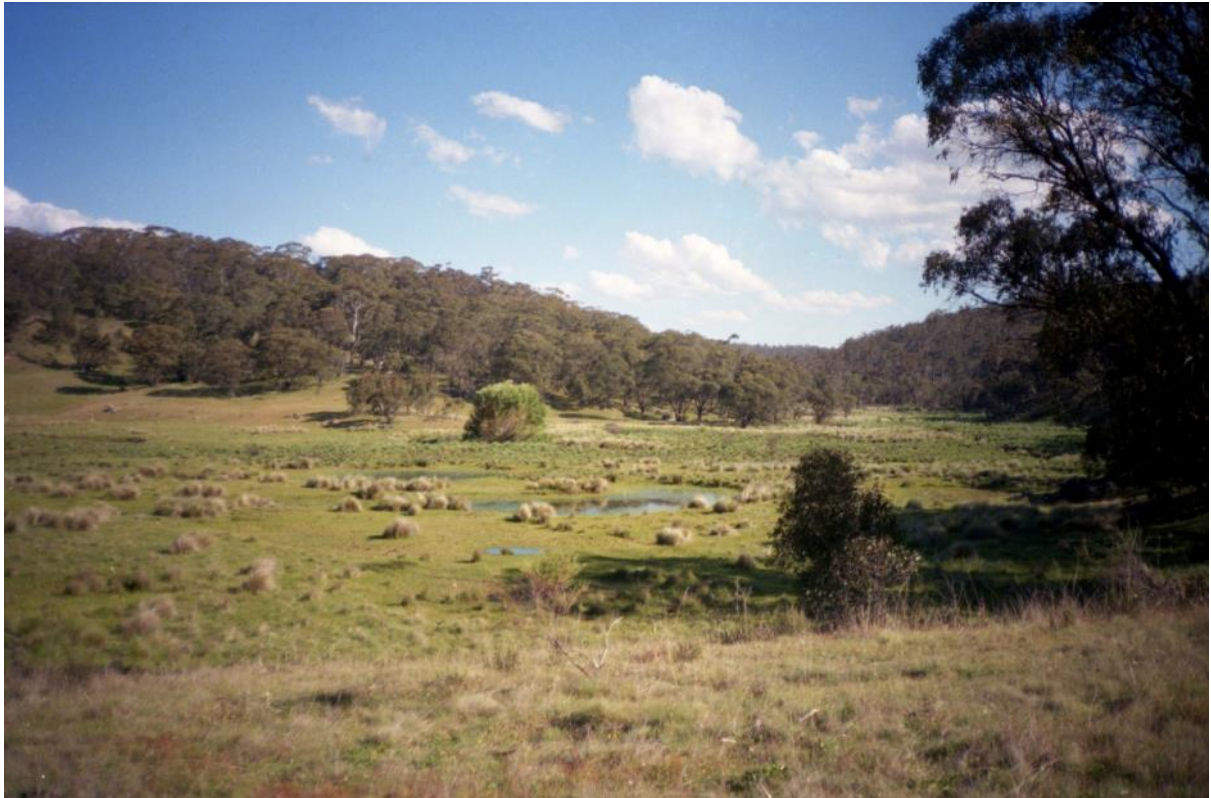
Dec 1986: Original photo of Ingeegoodbee River wetlands at a time of lower pest horse population numbers; Ingeegoodbee River Flats, Kosciuszko National Park south of Freebody's Hut, (Source: Di Thompson).

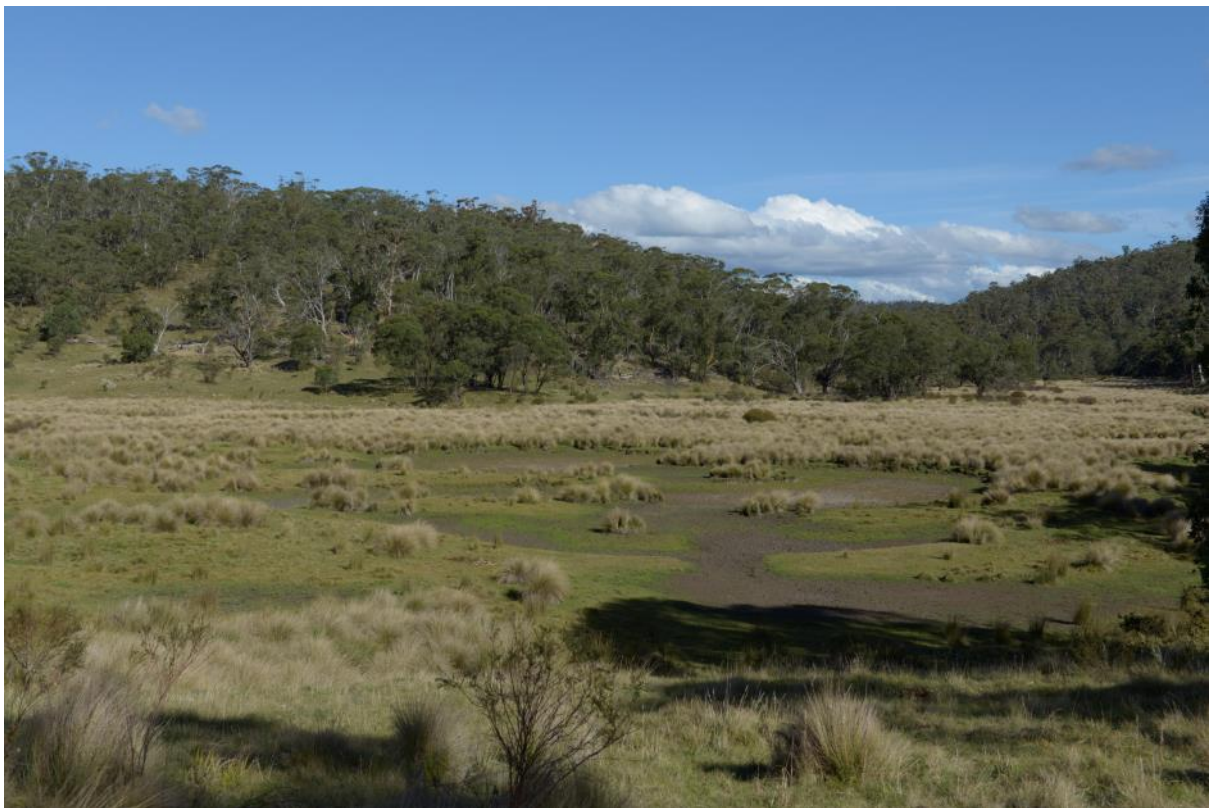
March 2013: Comparative photo taken 27 years later of pest horse damage Ingeegoodbee River Flat wetlands, Kosciuszko National Park, south of Freebody's Hut (Source: Graeme L. Worboys).

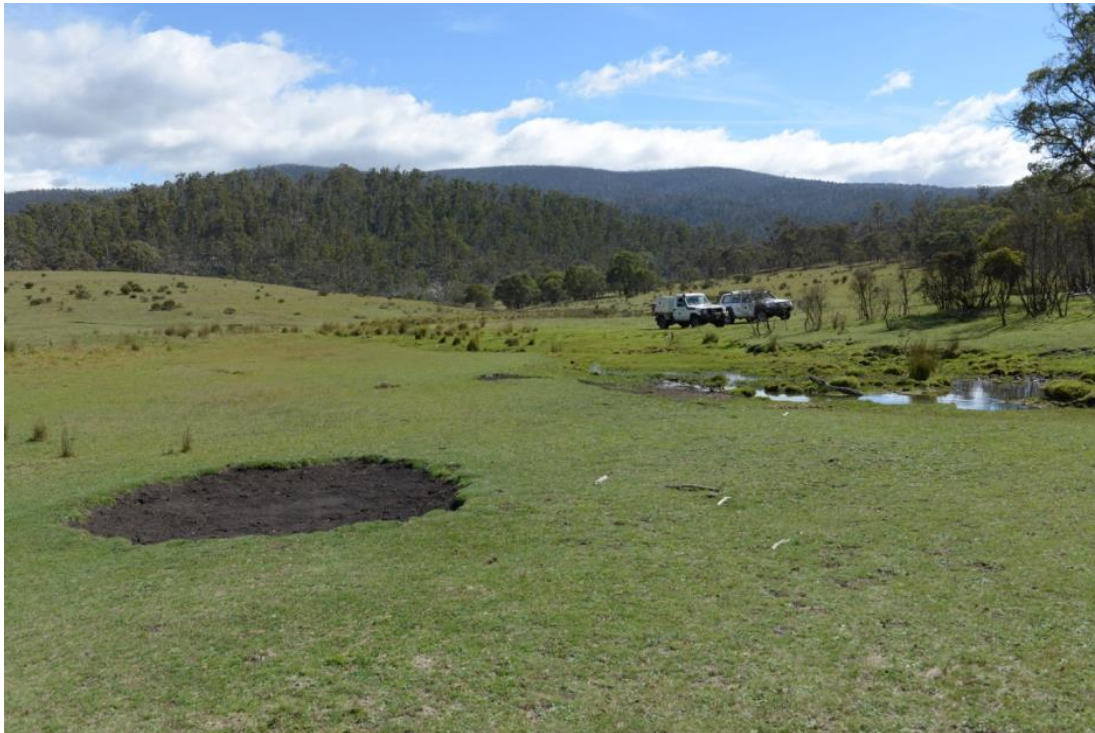
Dust baths are used by the pest horses to roll in as part of their cleansing and are a ubiquitous feature of these disturbed landscapes.

Horse dust bath, Cowombat Flat, Victoria, 100 metres south and east of the NSW border
(Source: Graeme L. Worboys).

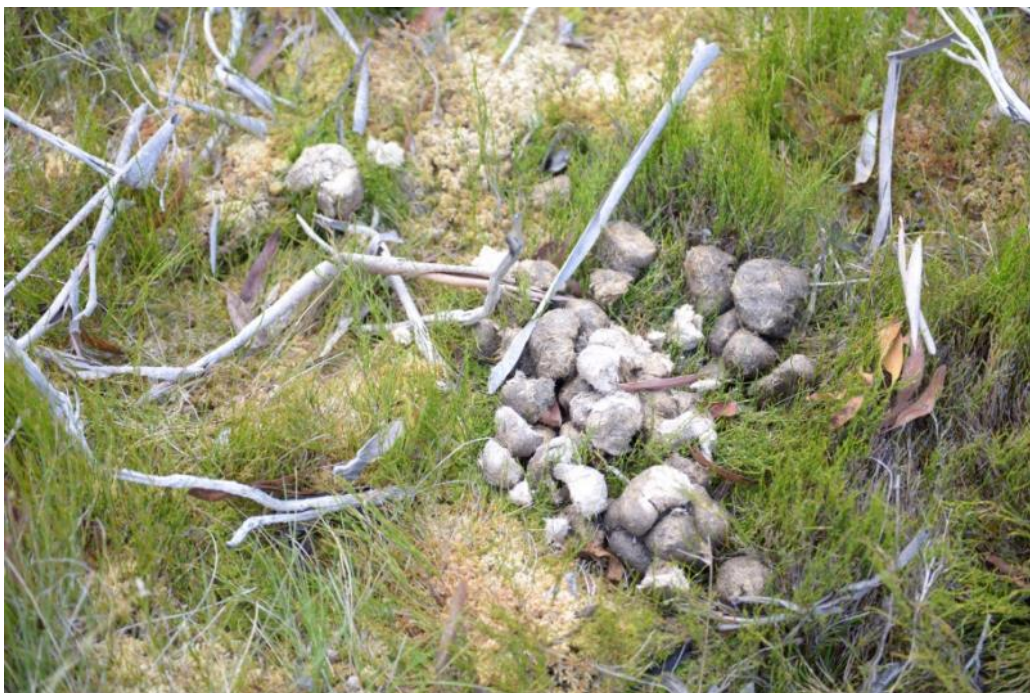
Streamside trampled *Sphagnum* moss (the light coloured plant) and horse faeces and between Cascades Hut and Tin Mine Hut, Kosciuszko National Park. The sponge-like Sphagnum helps to filter and slowly release water from stream side bogs (Source: Graeme L. Worboys)

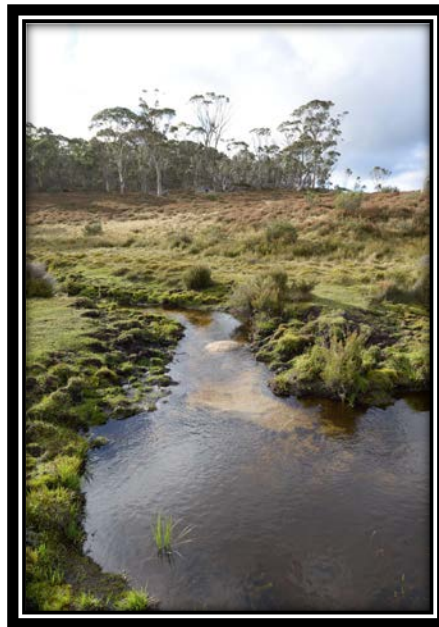
Pest Horse damage to stream banks, Ingeegoodbee River, near Tin Mine Hut, 23 March, 2013
(Source: Graeme L. Worboys).
